## DOCUMENTATION OF ENVIRONMENTAL INDICATOR DETERMINATION

Environmental Indicator (EI) RCRIS code (CA750)

### Migration of Contaminated Groundwater Under Control

Facility Name: Kimberly-Clark PA, LLC

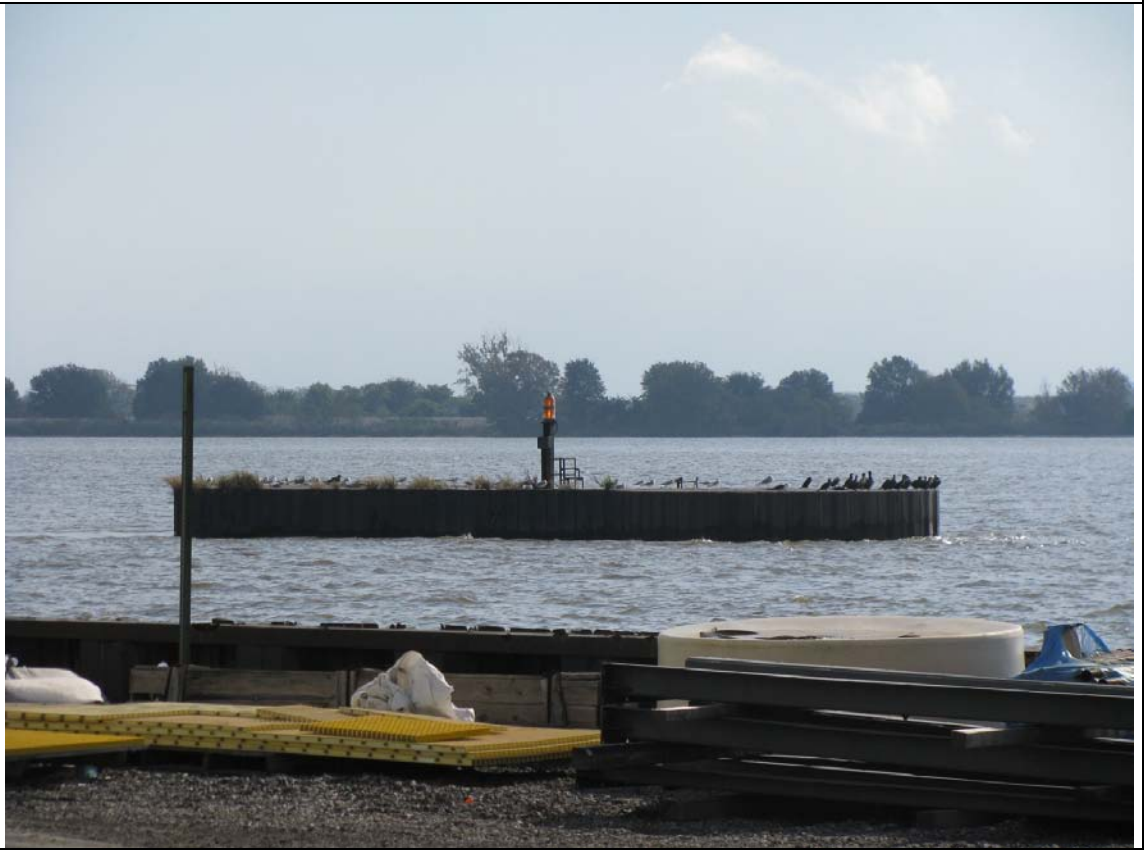
**Comments:** Facility's raw river water intake – Delaware River.

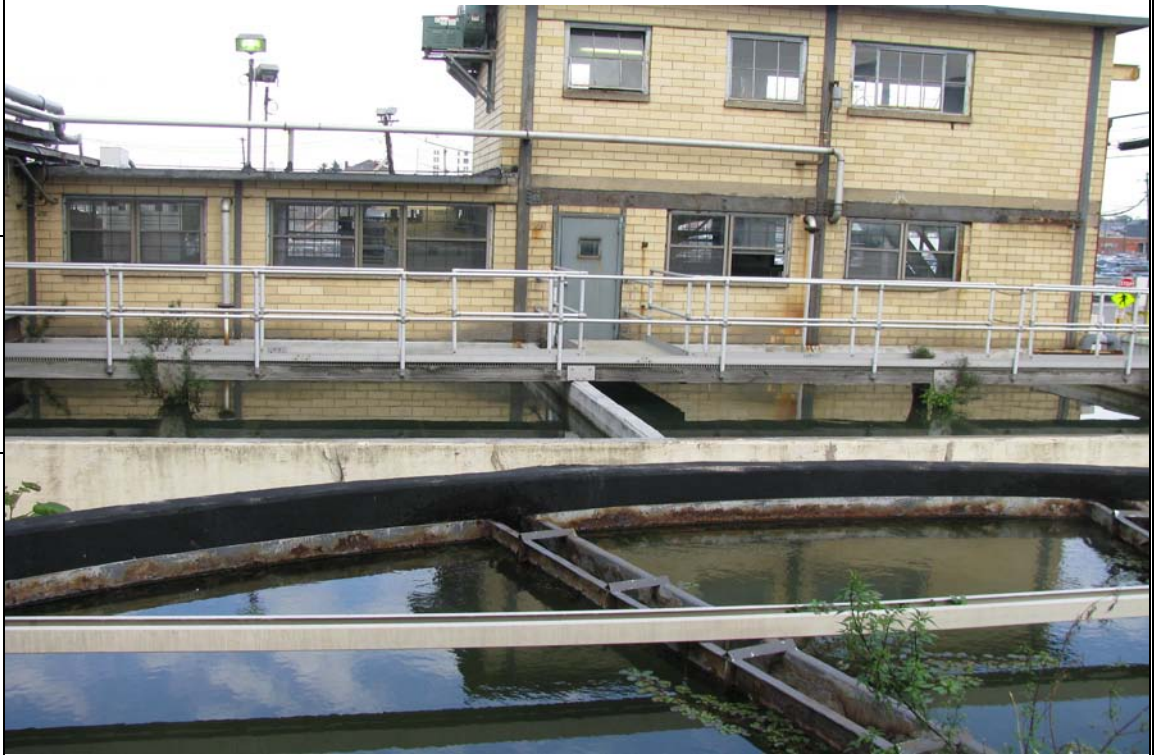
**Comments:** Raw water filter plant (clarifier, sand filters, and control building).

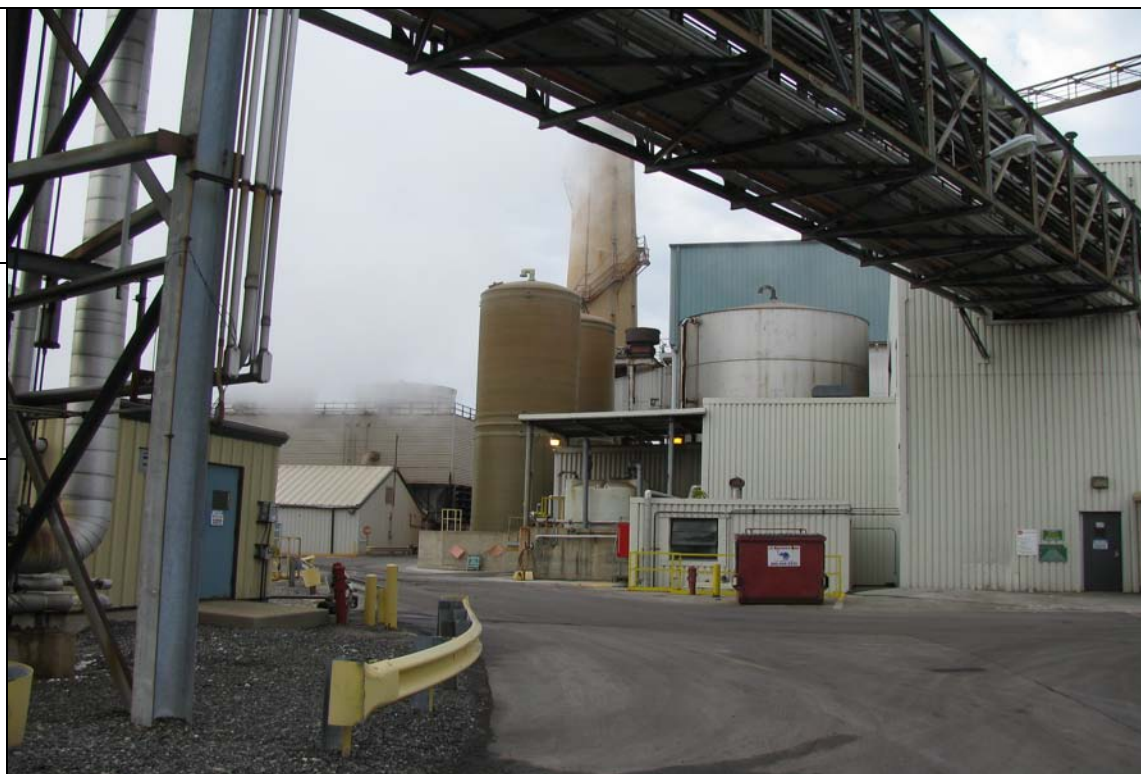
**Comments:** Wastewater elementary neutralization system neutralized water ASTs (Tanks 088 and 089) and caustic soda AST (Tank 084).

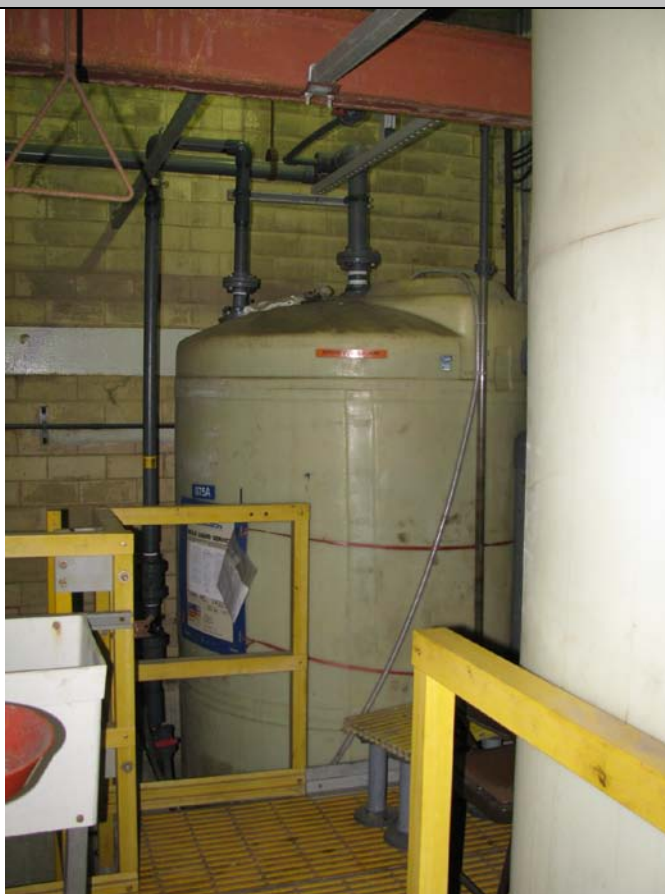
**Comments:** Wastewater elementary neutralization system sodium bromide AST (Tank 091).

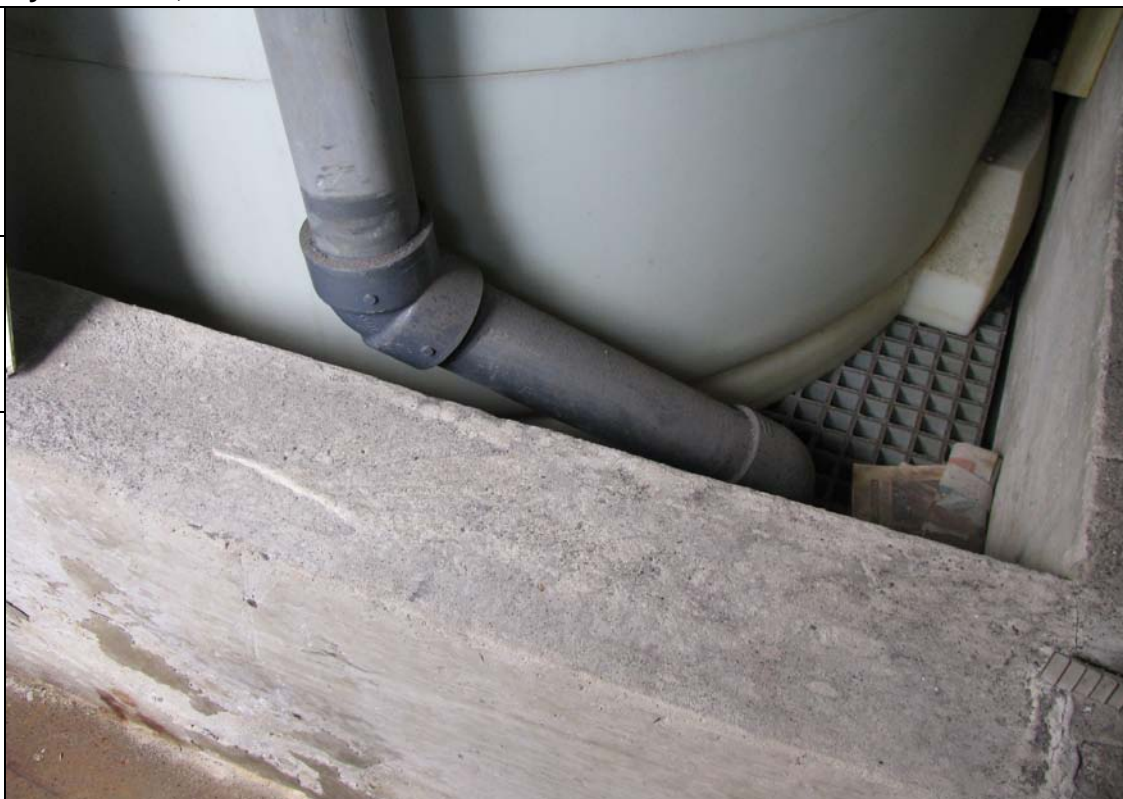
**Comments:** Wastewater elementary neutralization system sodium hypochlorite AST (Tank 092)  
(view of secondary containment).

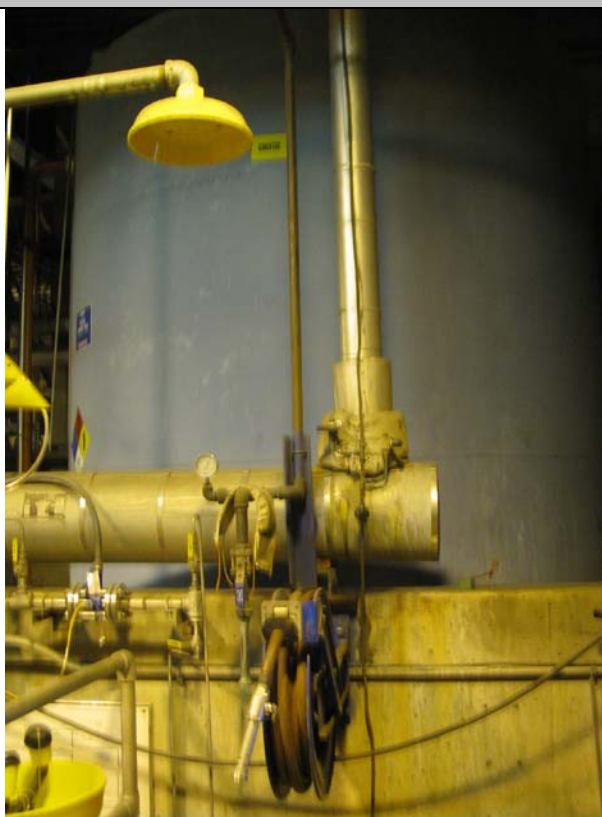
**Comments:** Wastewater elementary neutralization system sulfuric acid AST (Tank 093).

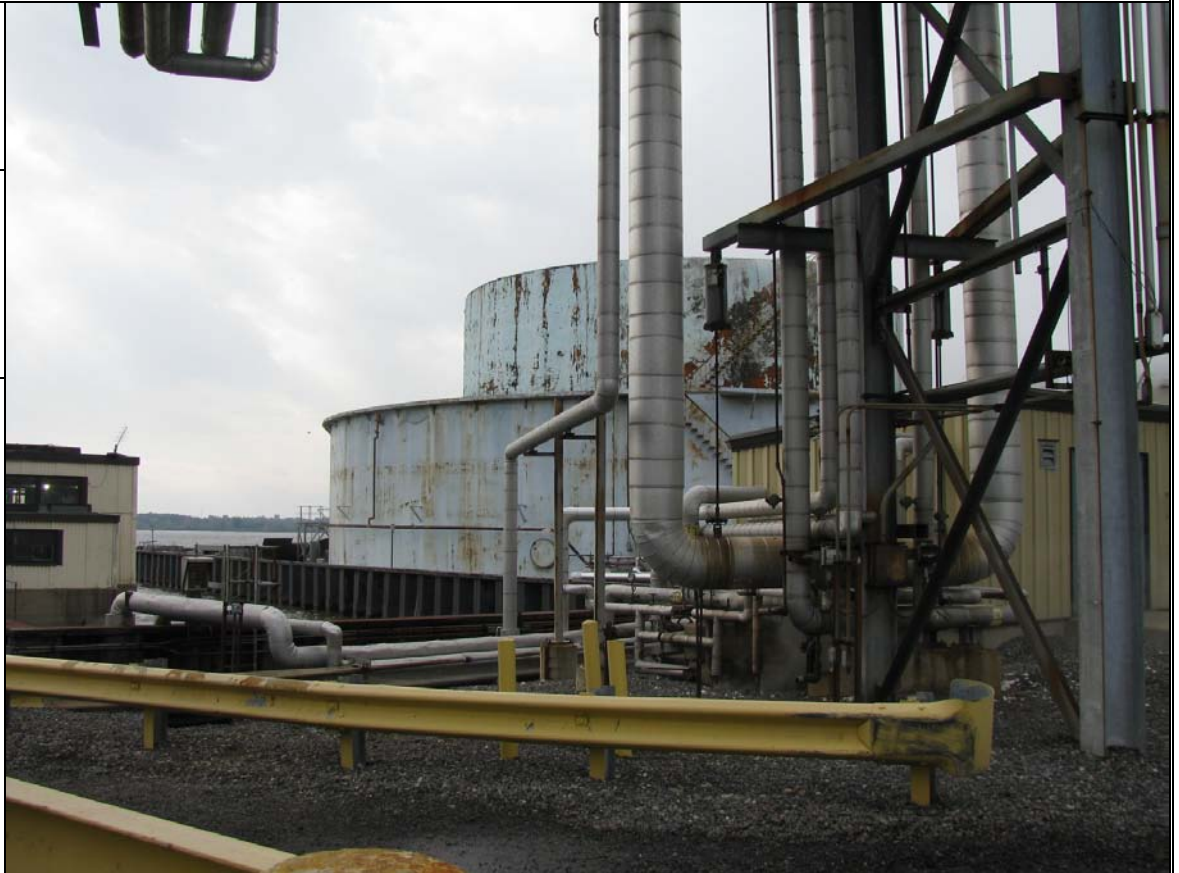
**Comments:** No. 6 fuel oil AST (Tank 058) located in the No. 2 Fuel Oil Area.

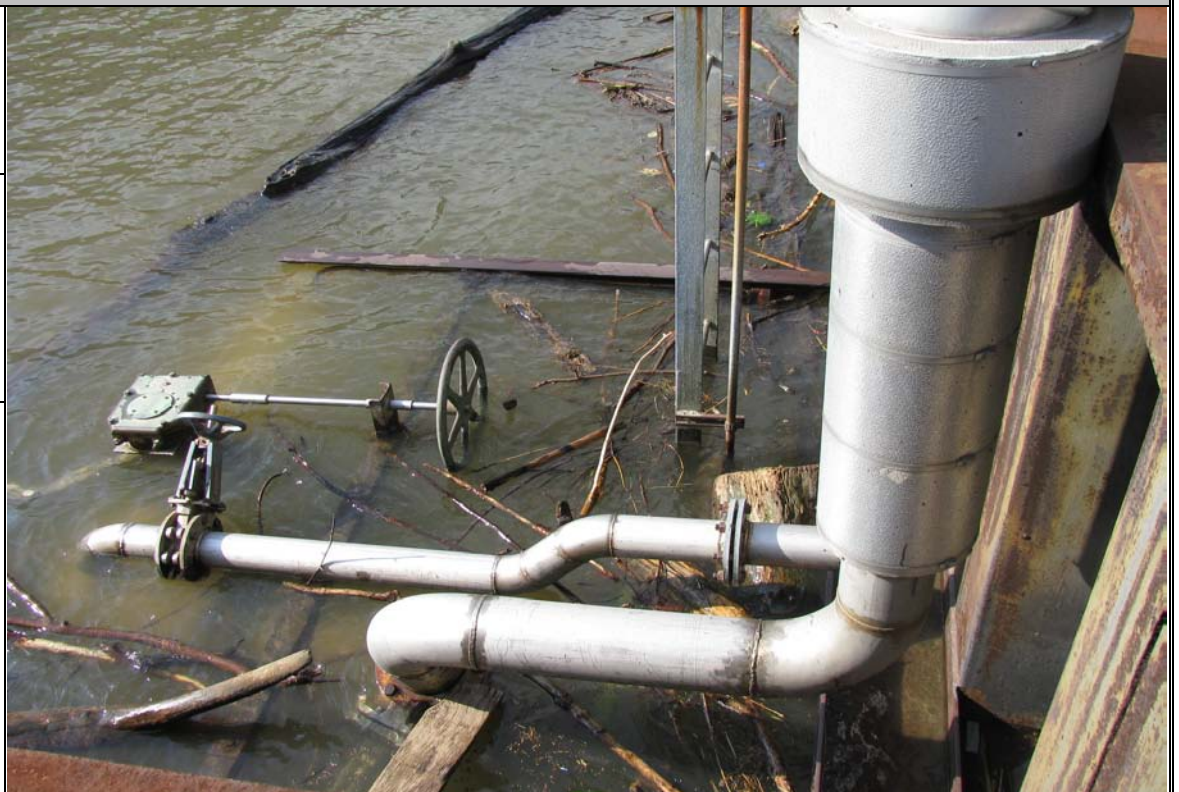
**Comments:** Outfall 001 – Emergency outfall for raw water filter plant.

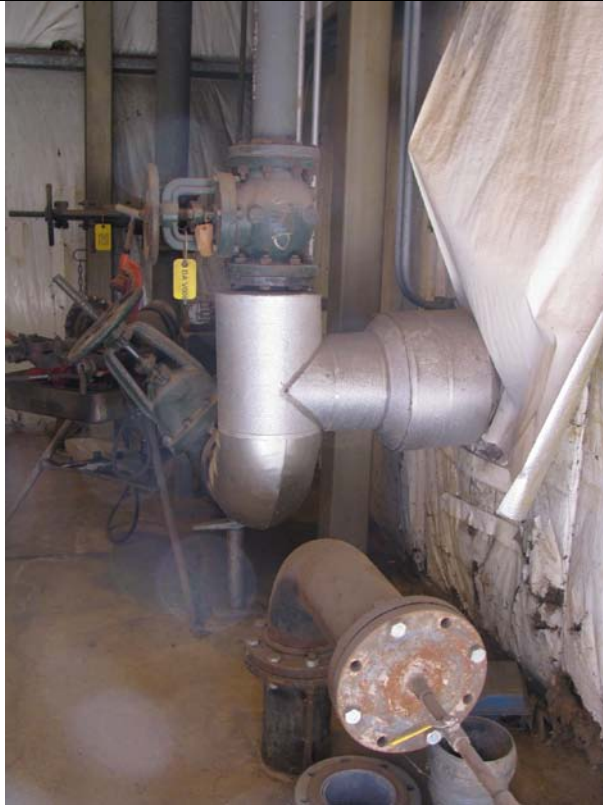
**Comments:** Outfall 006 – Recently redirected into the raw water filter plant.

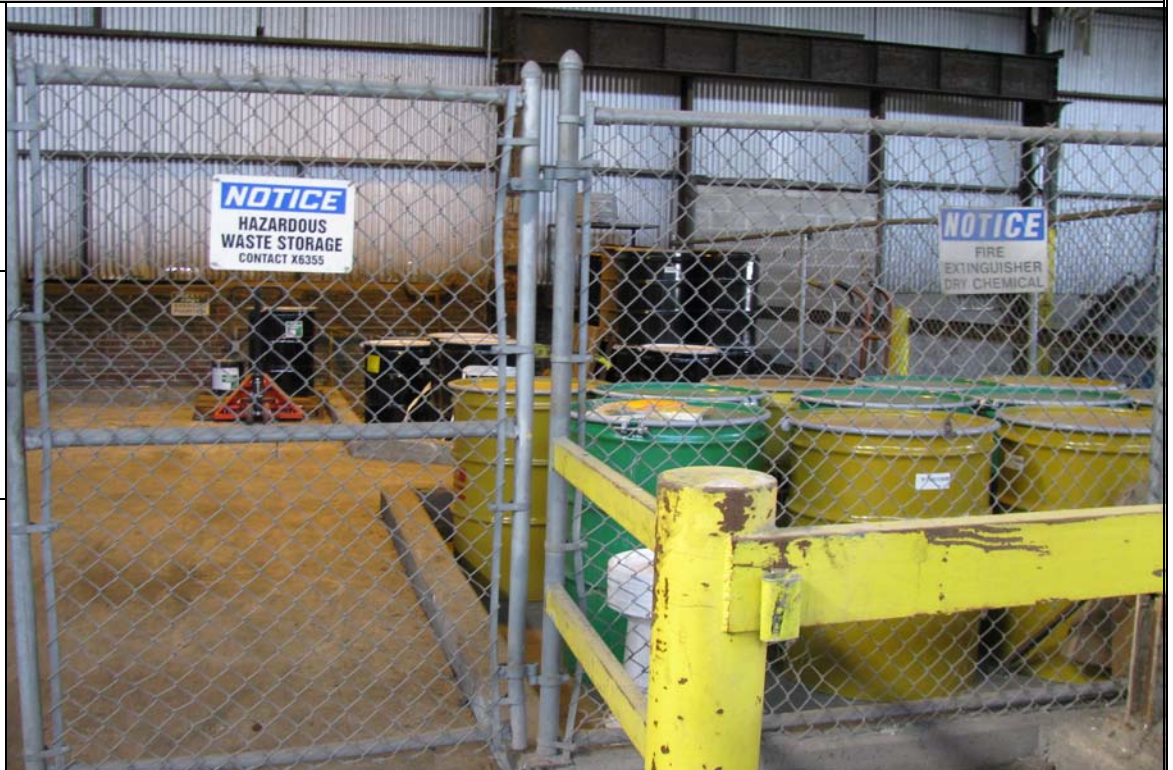
**Comments:** Building 81 – Hazardous waste accumulation area.

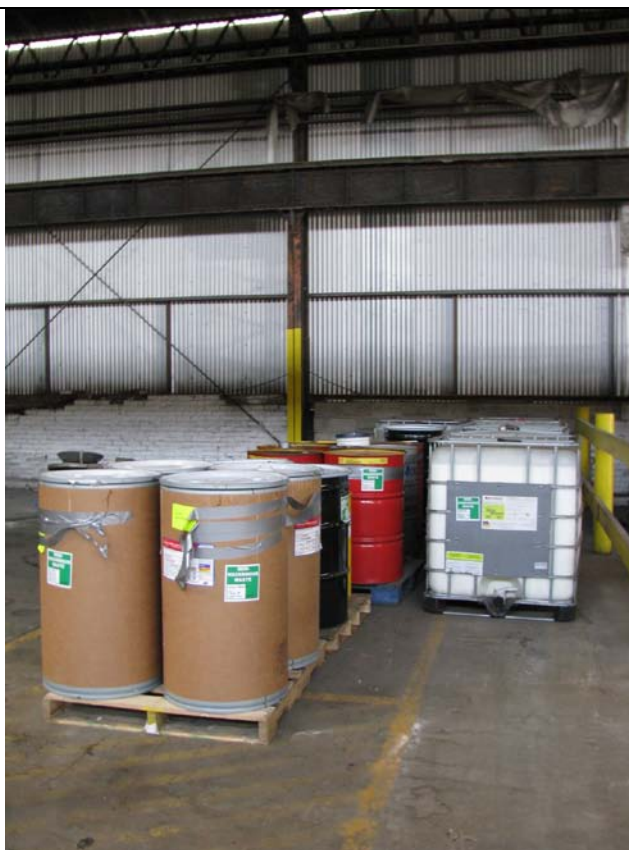
**Comments:** Building 81 – Nonhazardous waste accumulation area.

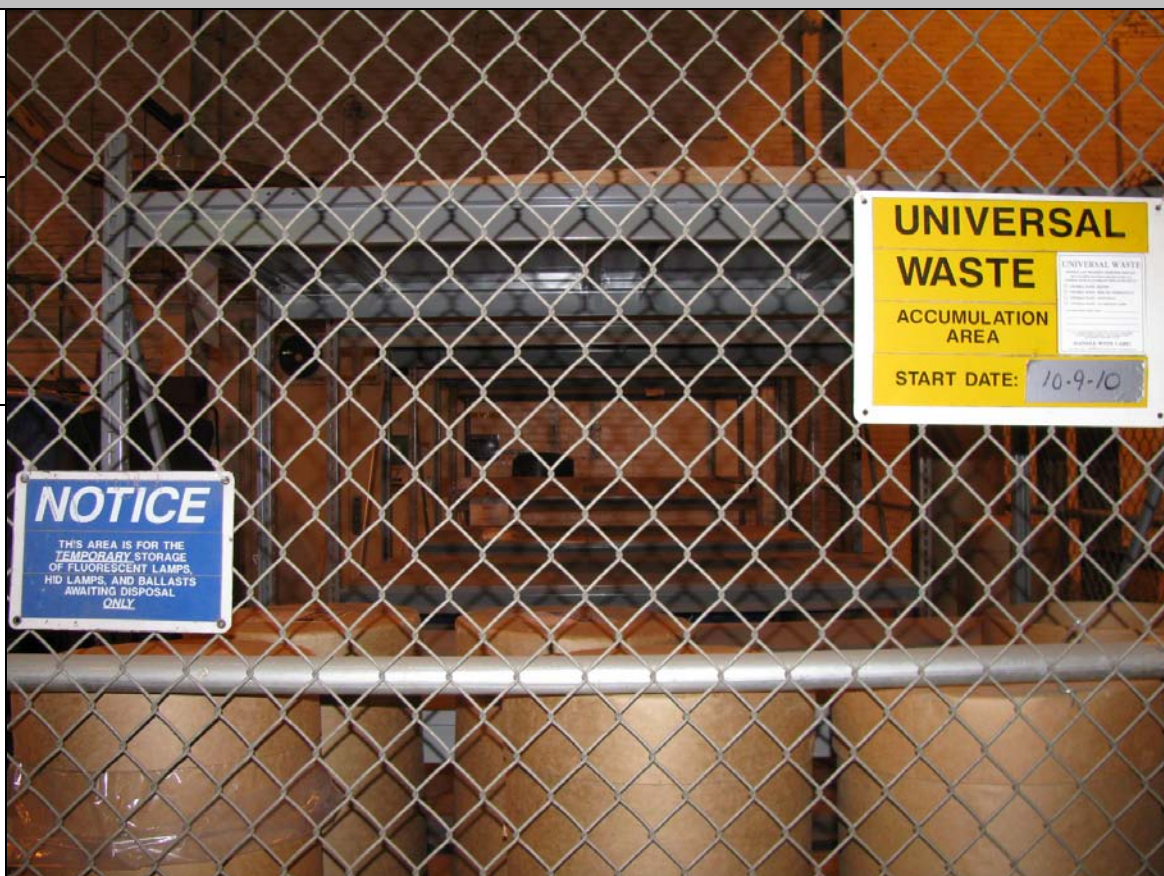
**Comments:** Universal waste accumulation area inside of mill.

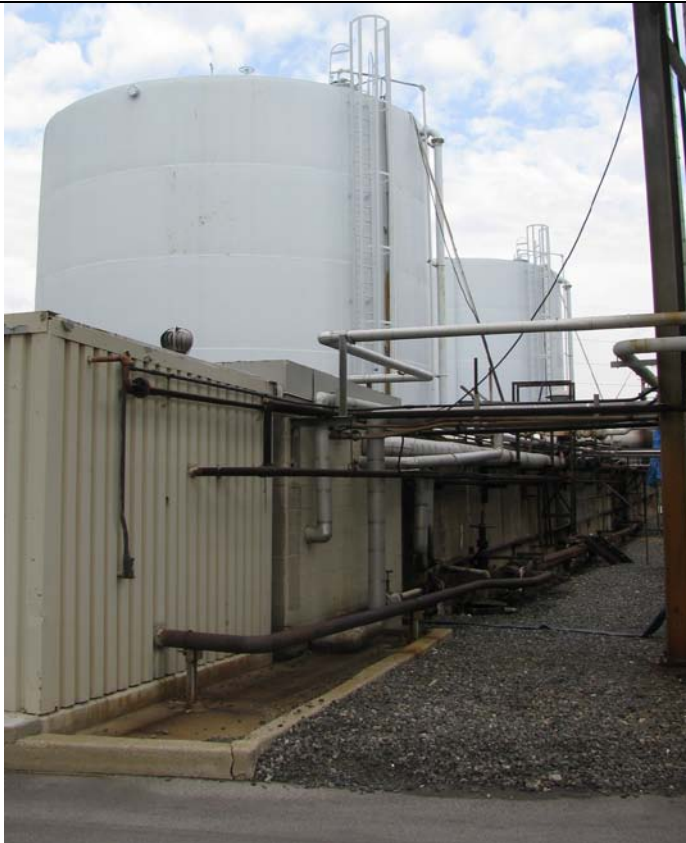
**Comments:** No. 2 fuel oil ASTs (Tanks 056 and 057) in the No. 2 Fuel Oil Area.

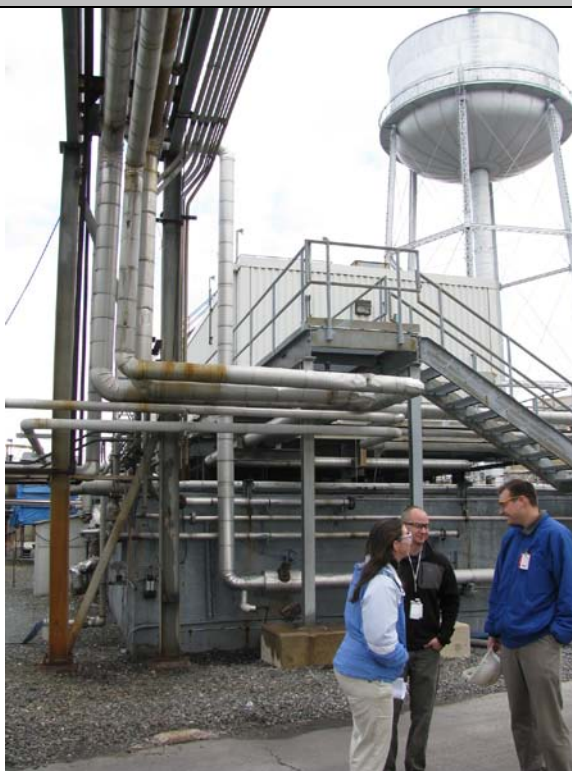
**Comments:** No. 2 Fuel Oil Area showing new aboveground piping and area where SPL was encountered.

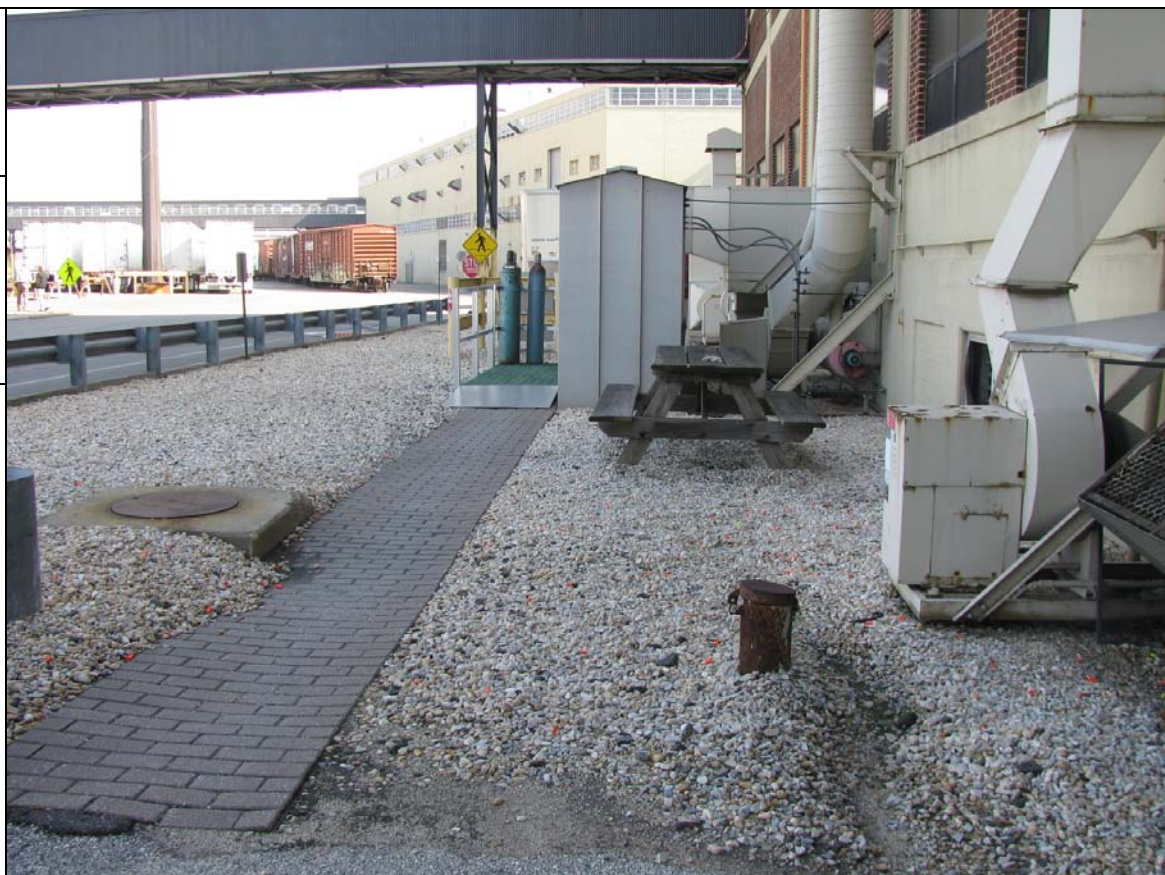
Contaminated soil was also left in place in the Mill Area UST Removal Area. Although a dual-phase remediation system was proposed for this area, available documentation suggests it was not installed. Therefore, the current chemical quality of the soil is unknown. The majority of the excavation areas are gravel-covered. In the Penn Steel Area, SPL remains in the subsurface; however, the areas where SPL was observed are asphalt-covered.

**Comments:** Mill Area UST Removal Area (MW-8 in foreground).

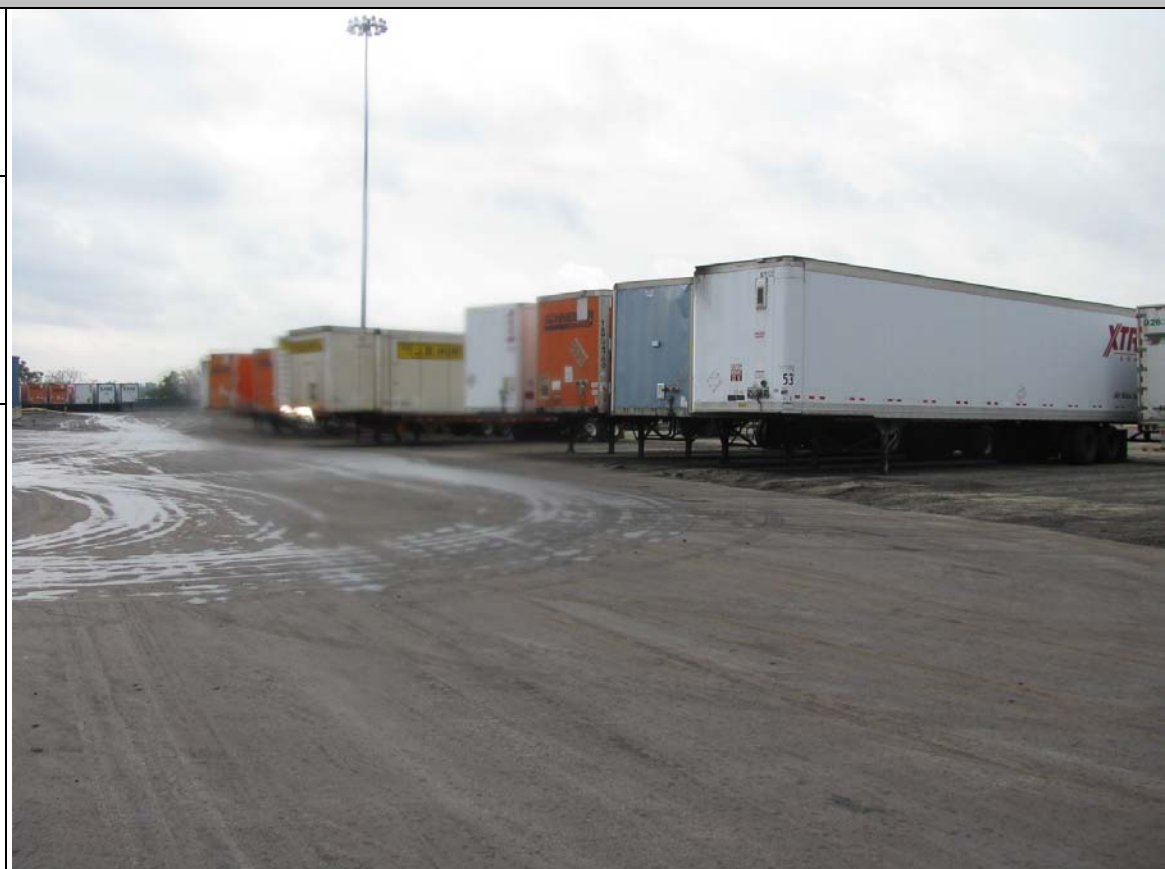
Groundwater analytical data for the Penn Steel Area suggests that while residual SPL remains, it is no longer degrading groundwater above appropriate regulatory levels. Groundwater samples collected from the groundwater/SPL interface at monitoring wells MW-8 and MW-10 during five sampling events conducted from March 2000 through May 2001 showed that none of the analytes analyzed for were detected above the PADEP non-residential MSCs, except for benzene that was detected at monitoring well MW-8 (6.2 ug/L) above the MSC of 5 ug/L during one sampling event (May 2001). Benzene was not detected in either MW-8 or MW-10 above laboratory detection limits during any of the other sampling events. Removal of the SPL was deemed infeasible because it is present in isolated pockets or discontinuous sheens. According to the Final Report (Atlantic, 2001), the facility maintains the asphalt parking lot that was placed over the former Penn Steel operations, and the areas where SPL was identified.

**Comments:** Penn Steel Area – Asphalt cap over residual SPL.

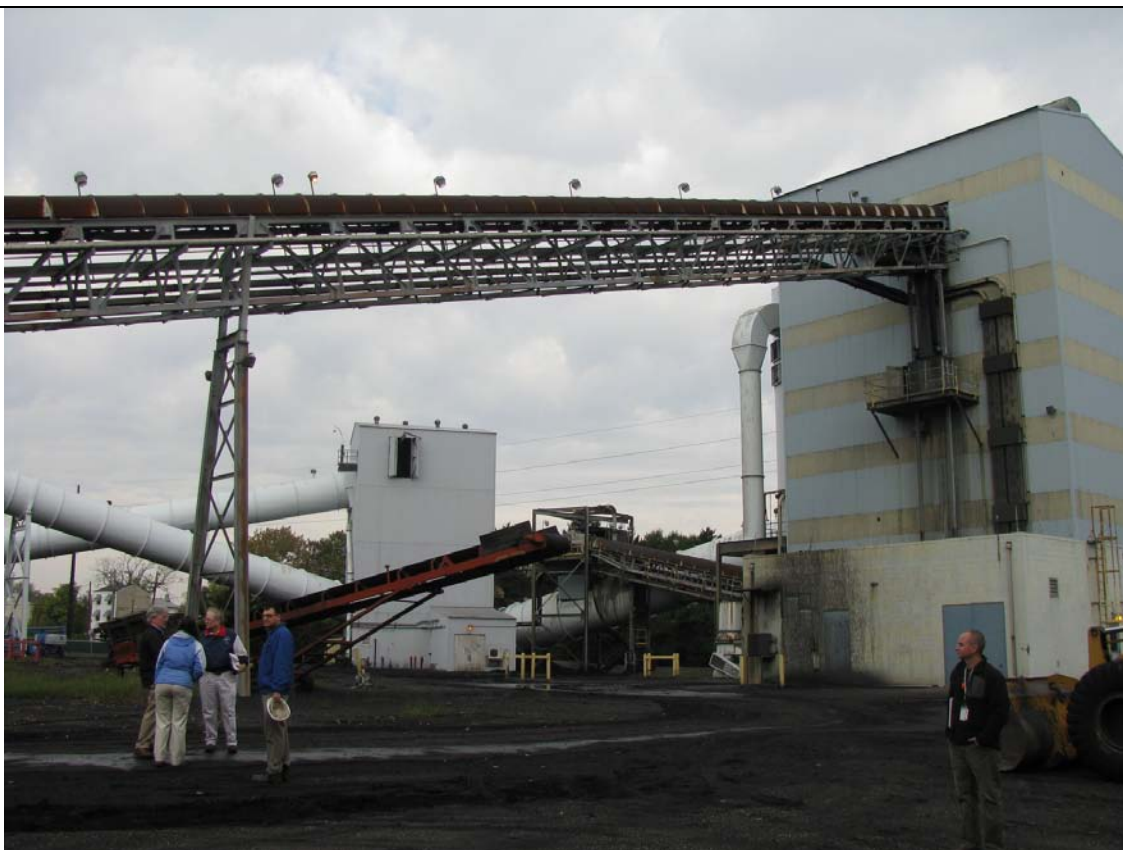
**Comments:** Penn Steel Area – Coal storage and handling structures.
